Kingfisher Pond - Northstowe Hydrogeological Assessment

Phase II Report

FWM8714-RT002-R02-00

May 2021

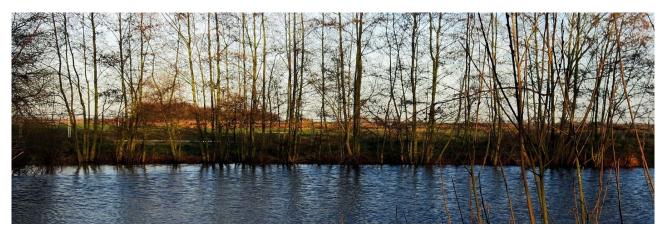
Photograph 5.1: The Kingfisher Pond, January 2015

Photograph 5.1 shows the Kingfisher Pond in January 2015. Water levels are considered to be within the pond's natural range.

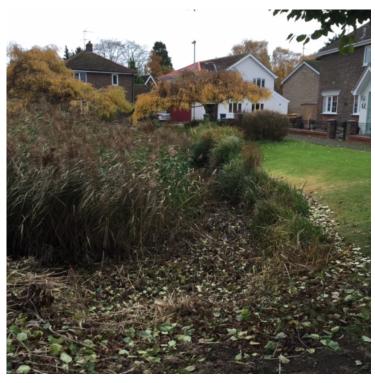
Photograph 5.6: Lady Walk Pond, autumn 2016

Lady Walk Pond, situation in a residential cul-de-sac, also reported low water levels in summer 2016. Photograph 5.6 shows the condition of Lady Walk Pond in autumn 2016.

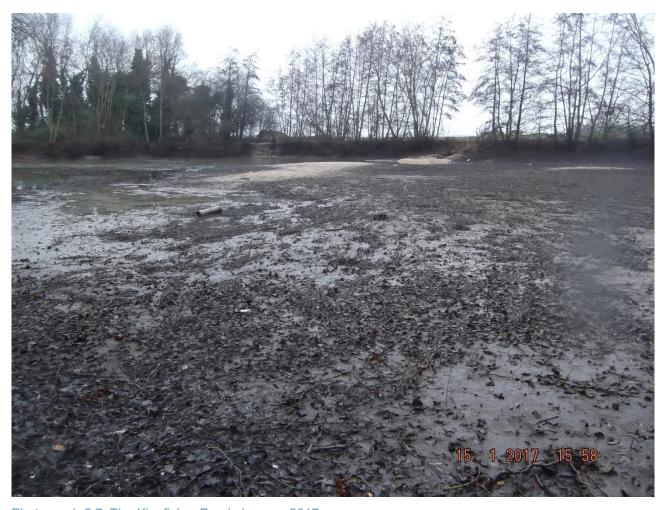
Photograph 5.7: The Kingfisher Pond, January 2017

In January 2017, the Kingfisher Pond was completely dried out as shown in Photograph 5.7. This photograph also highlights the depth of the pond to be relatively shallow, between approximately 1 m and 2 m.

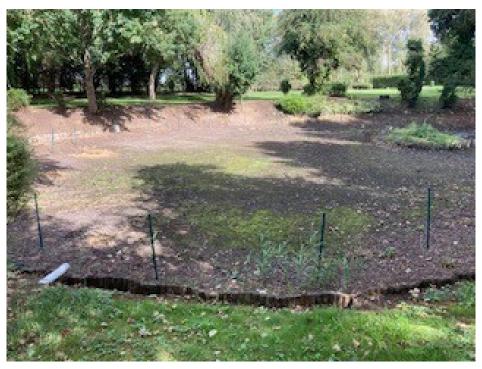
Photograph 5.10: Private pond located on St Michael's street, August 2020

Photograph 5.10 is of a pond located on private property in St Michael's street in August 2020. This pond has been reported by the owners to have completely dried. It has been in this condition for several years. The depth of the pond is approximately 1.5 m.

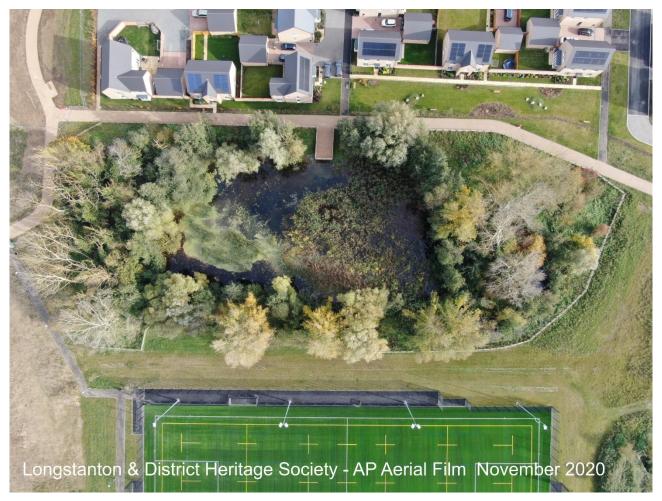
Photograph 5.13: The Kingfisher Pond, November 2020

Photograph 5.13 shows the low water level in the Kingfisher Pond in November 2020. The pond is not completely dry as was the case in previous winters of 2016 and 2017. Observational evidence from Longstanton District & Heritage Society suggests that the areas where the pond is directly on the gravel seam are several inches deep and therefore far below normal for this time of year.

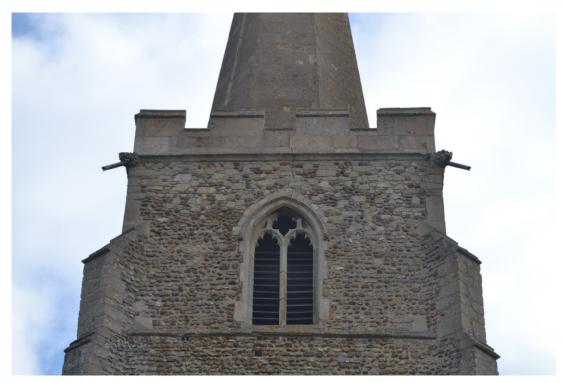
All Saints Church is situation on the corner of Rampton Road and the High Street. The church had visible cracks above the window and on the walls (Photograph 6.7). The structural changes were first reported in 2016. These structural changes could be the result of changes in the groundwater levels resulting in subsidence of the ground. However this cannot be determined without detailed investigation of the structural integrity and architecture of the church. This is beyond the scope of this report.

"....the below ground drainage should be checked as there are a number of cracks in the church which are suggesting some kind of movement probably caused by changing subsoil conditions."

Photograph 6.7: All Saints Church. Cracks above the church window are visible in this photograph

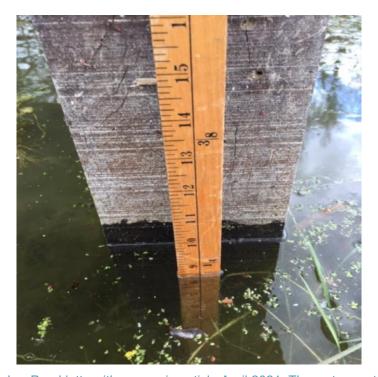
Photograph B.3: Kingfisher Pond jetty with measuring stick, April 2021. The water next to the outermost jetty post measured 9 inches

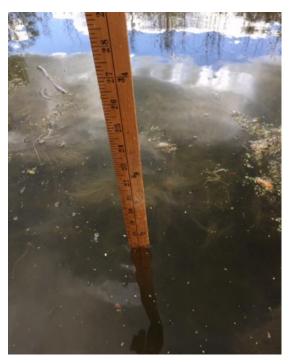
Photograph B.5: Kingfisher Pond with measuring stick, April 2021

Notes: This measurement was taken as near the centre as I could reach will my boots on. This measurement is 17
