Kingfisher Pond - Northstowe Hydrogeological Assessment

Phase II Report

FWM8714-RT002-R02-00

May 2021

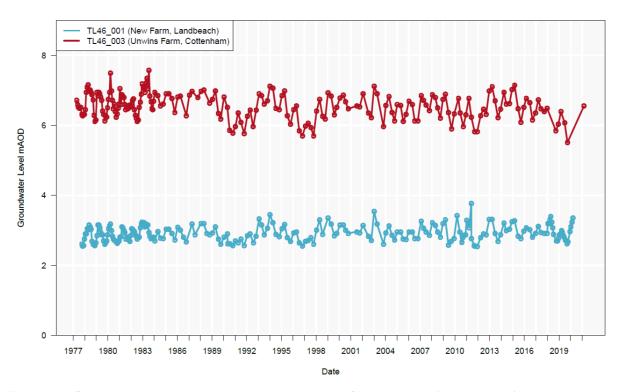
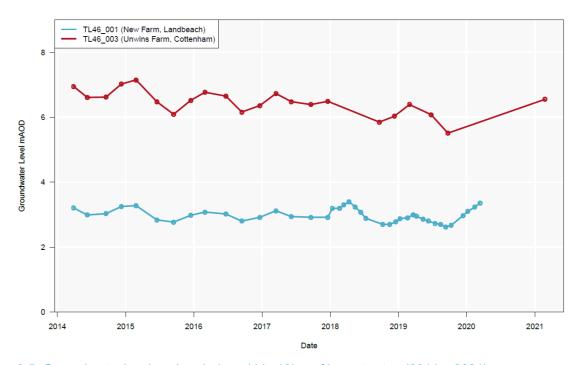
Figure 3.4: Groundwater levels at boreholes within 10km of Longstanton (1977 – 2021)

Figure 3.5: Groundwater levels at boreholes within 10km of Longstanton (2014 – 2021)

The groundwater levels presented in Figure 3.4 and Figure 3.5 demonstrate the seasonal fluctuations in the RTD. Minimum groundwater elevation typically occurs in September or October and maximum groundwater elevation typically occurs in March.

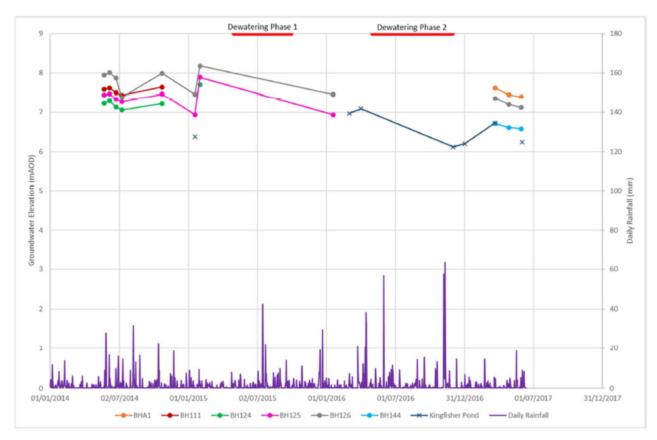
Figure 3.7: Groundwater elevation for Northstowe monitoring boreholes, surface water elevation for the Kingfisher Pond and daily rainfall for the period January 2014 to May 2017

However, the available data for BH125 and BH136 recorded in January 2015 and January 2016 shows that groundwater elevations recorded in January 2016 were comparable to those recorded in January 2015. Groundwater levels in March 2017 were lower than the winter of 2016.

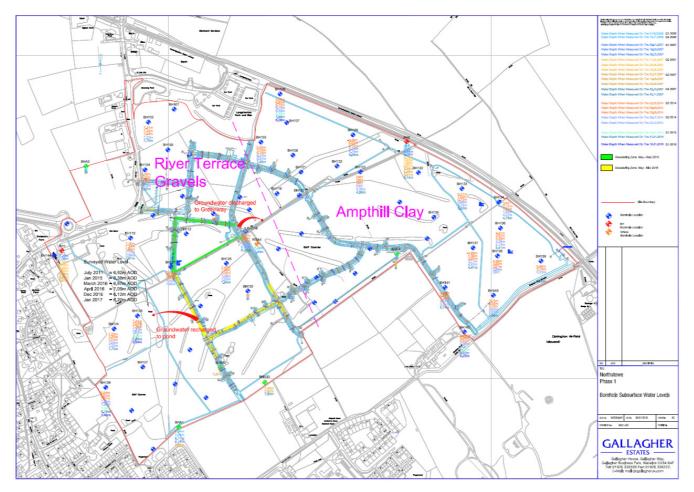
Figure 4.1: Borehole subsurface water levels. Site of Phase 1A dewatering indicated in green. Site of Phase 1B dewatering indicated in yellow

The discharge of water back to the Kingfisher Pond did not sufficiently return water levels to pre-construction water levels in the long term. This is further discussed with observational evidence in Section 5.

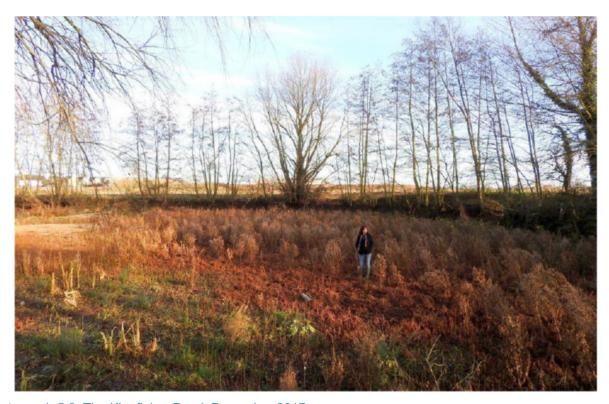
Photograph 5.8: The Kingfisher Pond, December 2017

In December 2017, the Kingfisher Pond was completely dry (Photograph 5.8) This was comparable to the previous winter. The overflow pipe which normally allows water to run from the Kingfisher Pond into the drainage system was likewise dry.

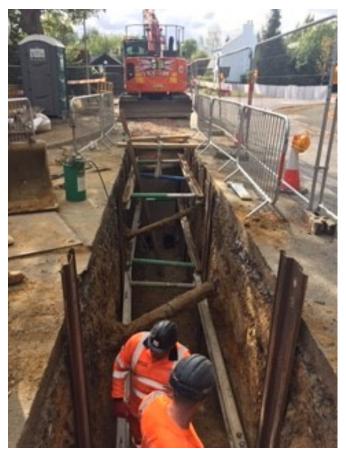
Photograph 5.9: Northstowe construction, September 2019

Photograph 5.9 of construction works in September 2019 shows that the groundwater level is not visible. The depth of the trench is approximately 1.5 m to 2.0m below surface level, indicating that the groundwater elevation is below this level.

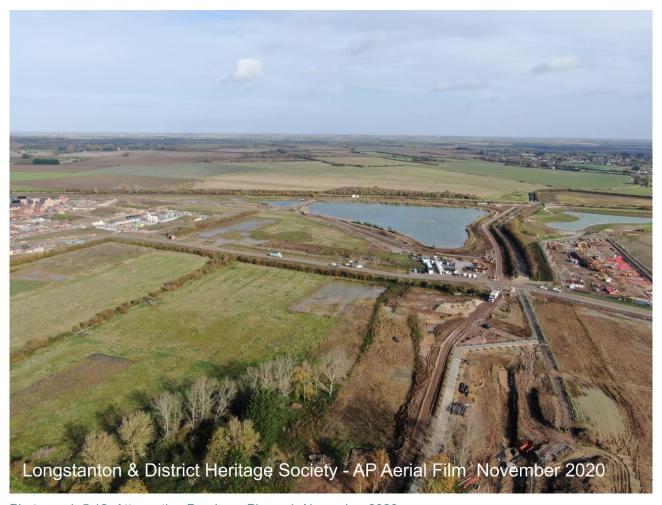
Photograph 5.12: Attenuation Ponds on Phase 1, November 2020

In autumn 2020, aerial photographs of the attenuation ponds on phase 1 (Photograph 5.12) show standing water in the attenuation ponds. As stated in Section 4.2, these ponds form part of the surface drainage strategy of Northstowe and are intended to attenuate surface run off. These ponds are clay lined.

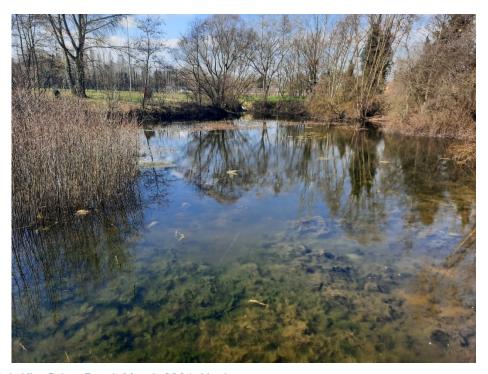
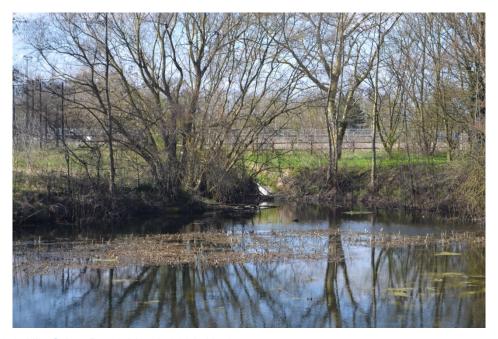
This current state of the pond contrasts with previous reports of the pond having a low water level and previously completely dried out. The pond has therefore visibly recovered. Local residents confirmed that the level of water in the pond was at the highest it had been for several years (circa. 2015). The level of the pond had improved since February 2021.

Photograph 6.1: Kingfisher Pond, March 2021. No.1

Photograph 6.2: Kingfisher Pond, March 2021. No.2

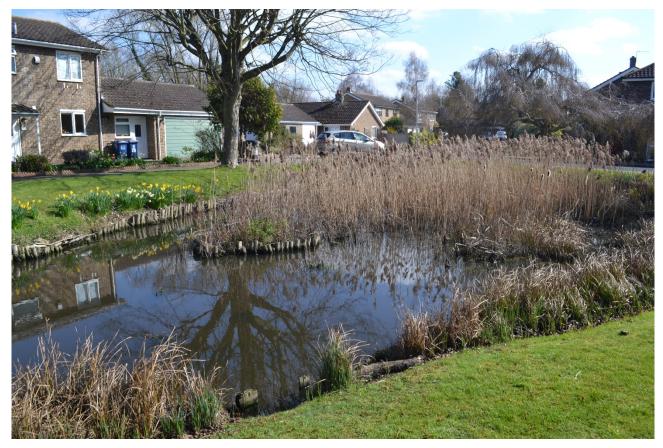
Photograph 6.4: Lady Walk Pond, March 2021

Lady Walk Pond is a small pond situated in the cul-de-sac Lady Walk. As with the Kingfisher Pond, this pond had previously been reported to completely dry out. In January 2021, the pond was completely dry however during the site visit in March 2021 the pond had substantially recovered (Photograph 6.4), This indicates the groundwater levels had risen significantly between February and March 20021. Local residents reported that the Lady Walk Pond was at its highest level since autumn 2015. The pond had abundant reedbeds which indicate a relatively shallow depth approximately 0.5 m to 1.0 m.

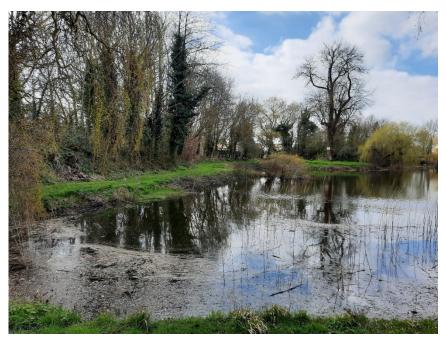
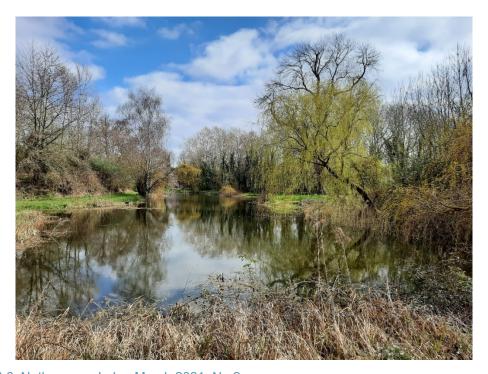
Consistent with the Kingfisher Pond and Lady Walk Pond, Nethergrove Lake had notable increased water levels. Mr Graham Tweed confirmed that the water levels at Nethergrove Lake were at the highest during March 2021 compared with the previous 5 years.

Photograph 6.5: Nethergrove Lake, March 2021. No.1

Photograph 6.6: Nethergrove Lake, March 2021. No.2
