Kingfisher Pond - Northstowe Hydrogeological Assessment

Baseline Conceptual Report

FWM8714-RT001-R03-00

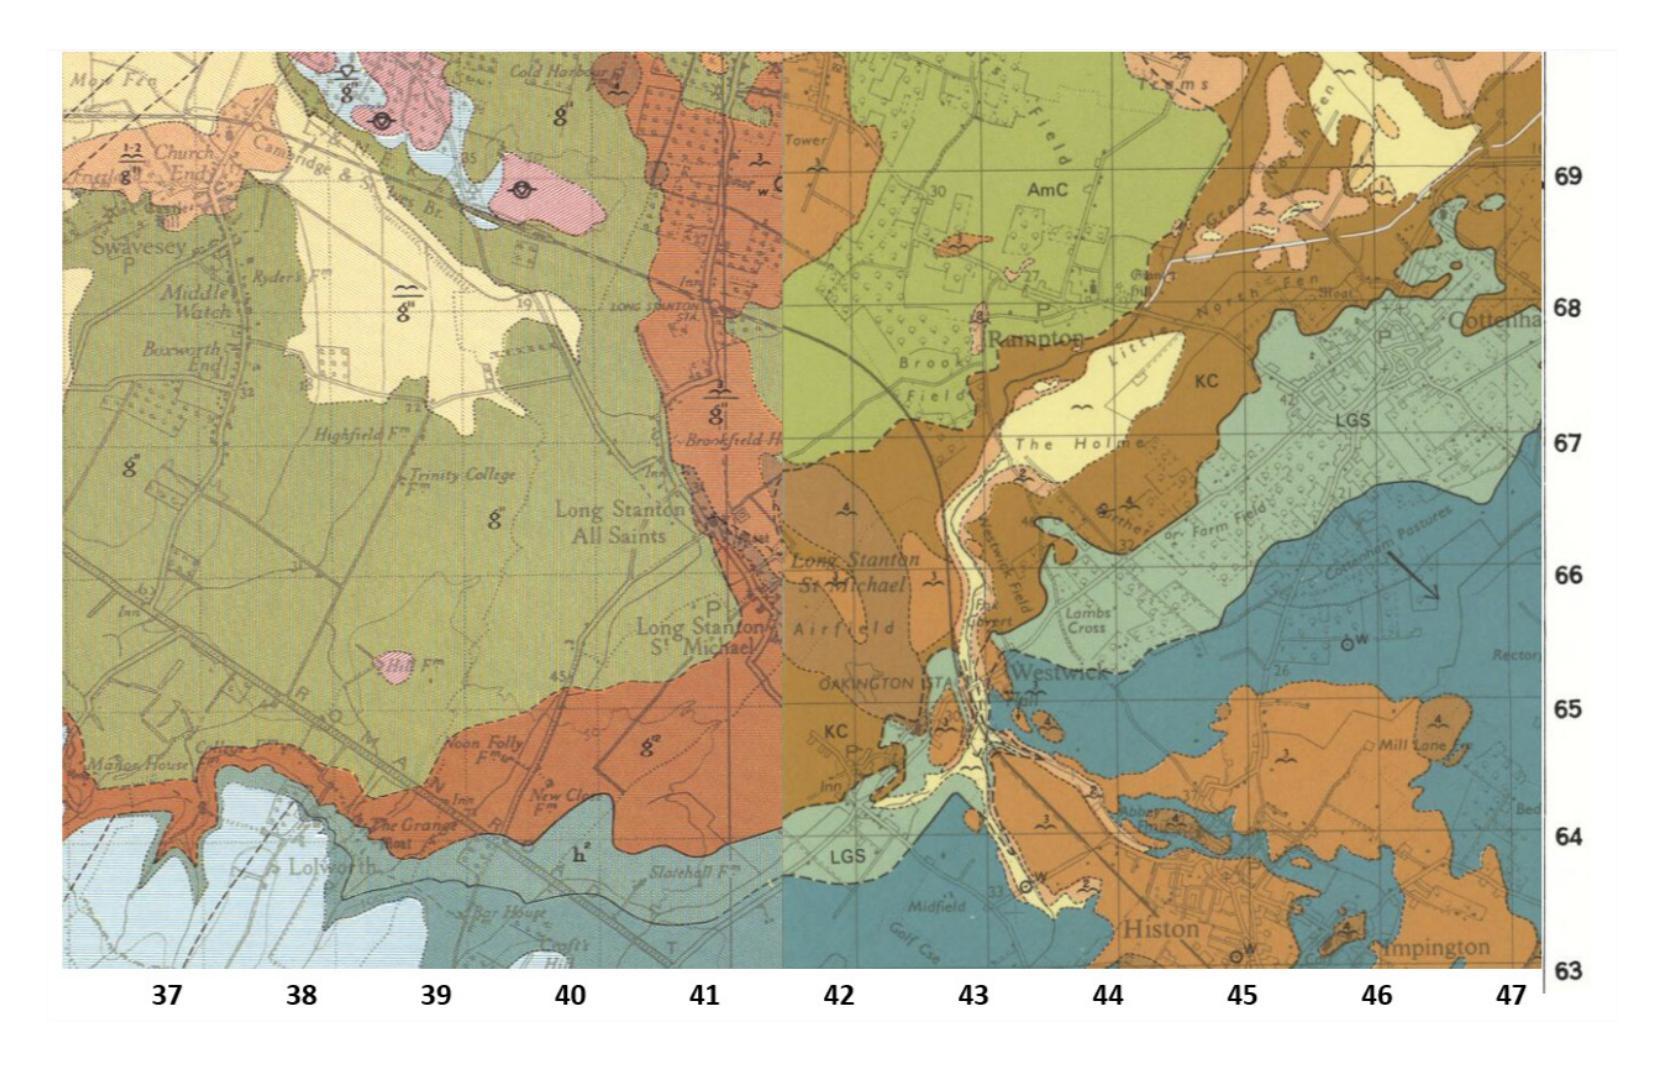
Figure 2.1: Solid and drift geological map of Huntington (187) and Cambridge (188)

Overlaying the bedrock are superficial deposits (Figure 2.1) The dominant superficial deposits is the class 2 River Terrace Deposits (RTD) which runs south to north through the centre of Longstanton. The RTD extends across the broader region, as far south as the city of Cambridge and continuing northward to the town of Chatteris.

A multitude of ponds and small lakes, including the Kingfisher Pond, are identifiable along the RTD. These water bodies are in hydraulic continuity with the groundwater and therefore the surface water levels reflect the groundwater levels of the RTD.

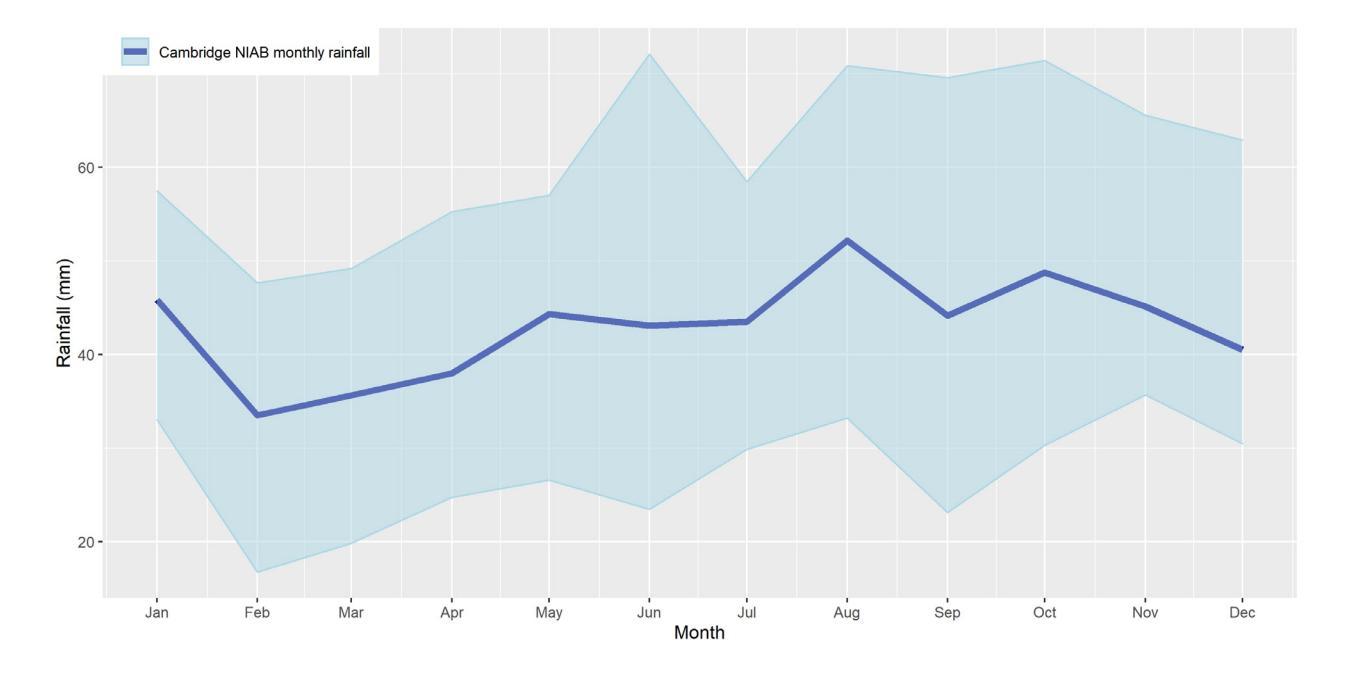
Figure 3.1: Monthly rainfall recorded at Cambridge NIAB meteorological station. Data from 01/01/1961 to 31/12/2014

Results show that for the period 1961 - 2014, rainfall on average falls evenly throughout the year. On average the wettest month is August and the driest is February (Figure 3.1). Annual average rainfall is 534mm. Figure 3.1 shows that though inter-annual fluctuation does occur, there is no long-term trend to suggest declining or increasing rainfall between 1961-2014.

Notes: Dark blue line is the median Q50 monthly rainfall Light blue ribbon is the range of Q25 to Q75 rainfall range

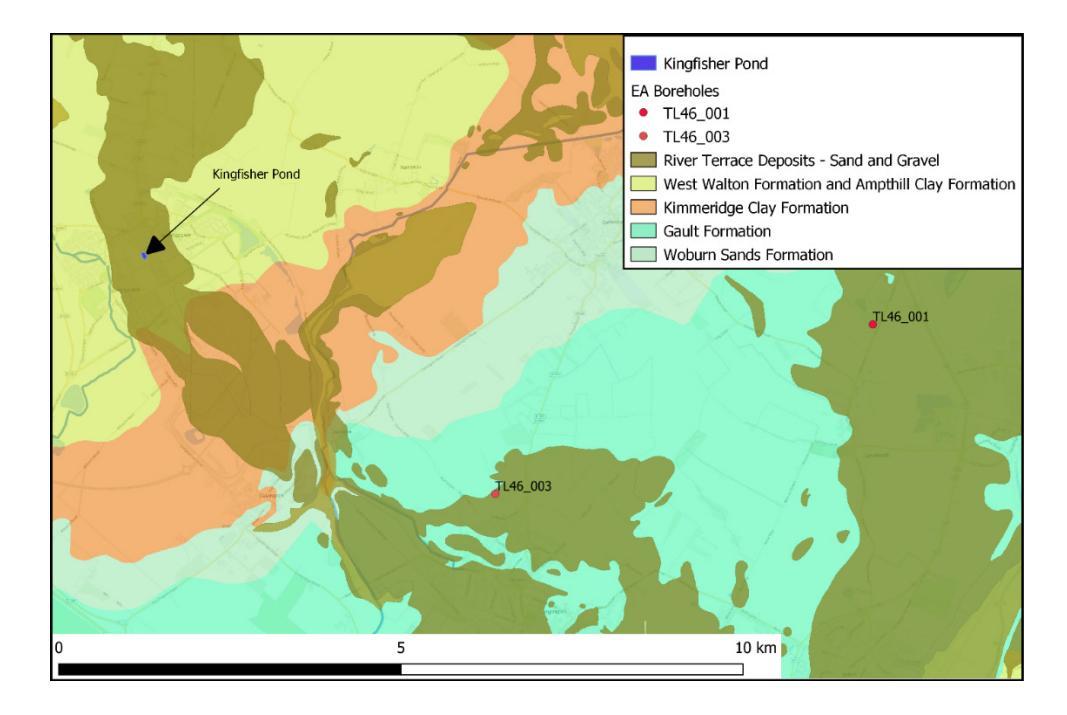
Figure 4.1: Map of boreholes TL46_001 (New Farm, Landbeach) and TL46_003 (Unwins Farm, Cottenham) in relation to the River Terrace Deposits and the Kingfisher Pond

Groundwater level data from the Environment Agency (2020) was provided for two boreholes within 10km of Longstanton (Figure 4.1). Both boreholes are located on the same RTD which underlies the Kingfisher Pond. Therefore, it is reasonable to assume that fluctuations in groundwater level in these two boreholes should be representative of seasonal and long-term trends in the groundwater level at the Kingfisher Pond. No borehole groundwater level in closer proximity to the Kingfisher Pond with timeseries data was available from the Environment Agency. The data provided covers the period between 1977 to 2019, however in this report only data prior to 2015 is presented to summarise changes in groundwater level prior to the observed decrease in surface water at the Kingfisher Pond.

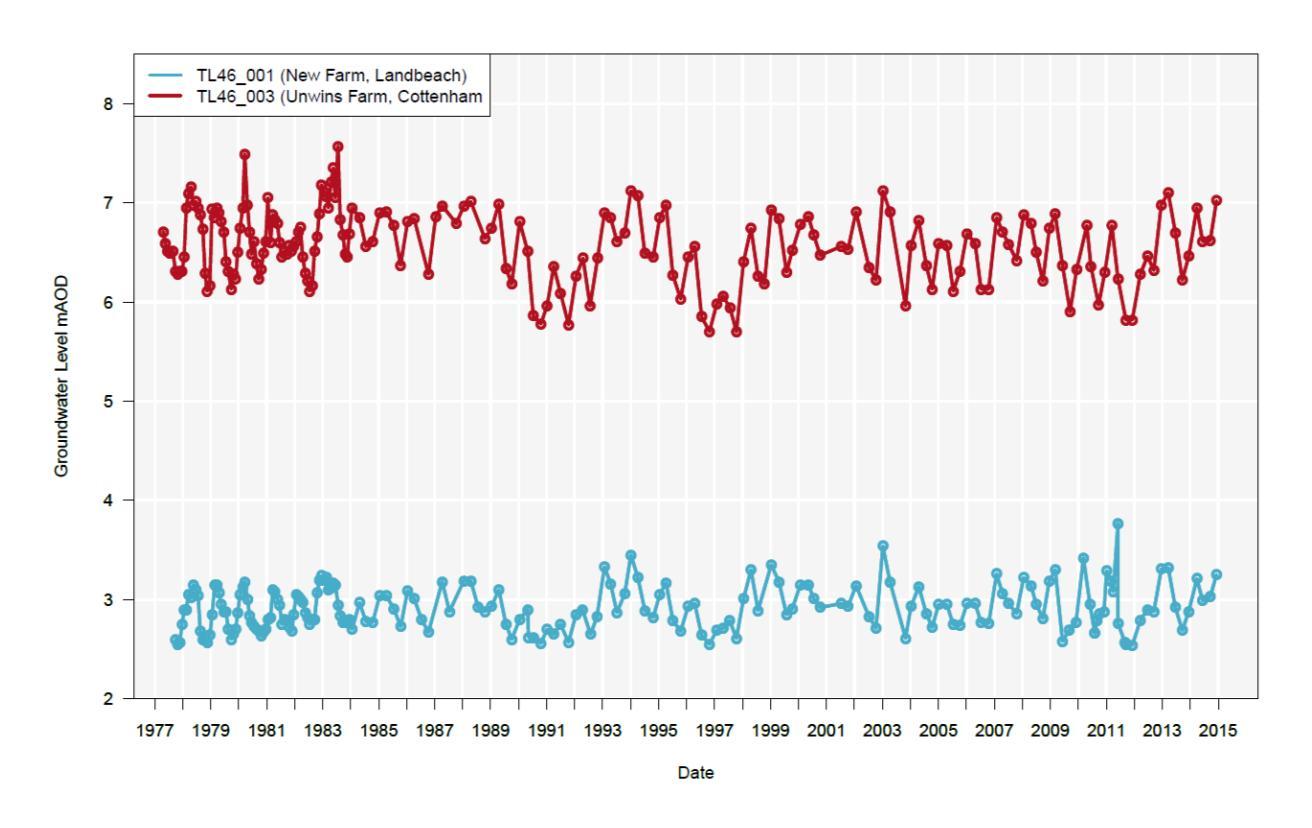
Figure 4.2: Groundwater levels at boreholes within 10km of LongstantonSource:Environment Agency, 2020

Figure 4.2 shows that the long-term fluctuations the groundwater level across the three boreholes has remained stable. Seasonal fluctuations are about 1 m. TL46_003 (Unwins Farm, Cottenham) has a groundwater level range between 6 mAOD and 7 mAOD, while TL46_001 (New Farm, Landbeach) has a groundwater level range between 2.5 mAOD and 3.5 mAOD.

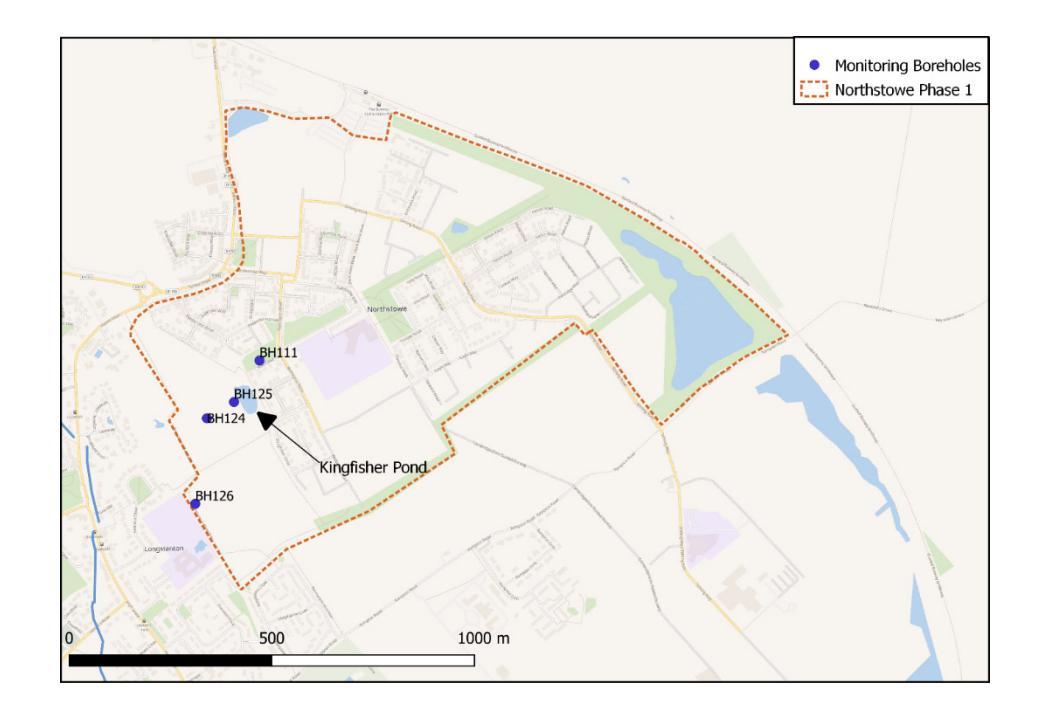
Figure 4.3: Map highlighting locations of boreholes of interest at Northstowe Phase 1 Source: Locations from Wardell Armstrong (2017) reproduced in QGIS

Borehole	Geology of response zone	Range of monitored groundwater levels (mAOD))
BH111	River Terrace Deposits	7.14 - 7.33
BH124	River Terrace Deposits	7.11 - 7.34
BH125	River Terrace Deposits	7.20 - 7.40
BH126	River Terrace Deposits	7.34 - 7.53

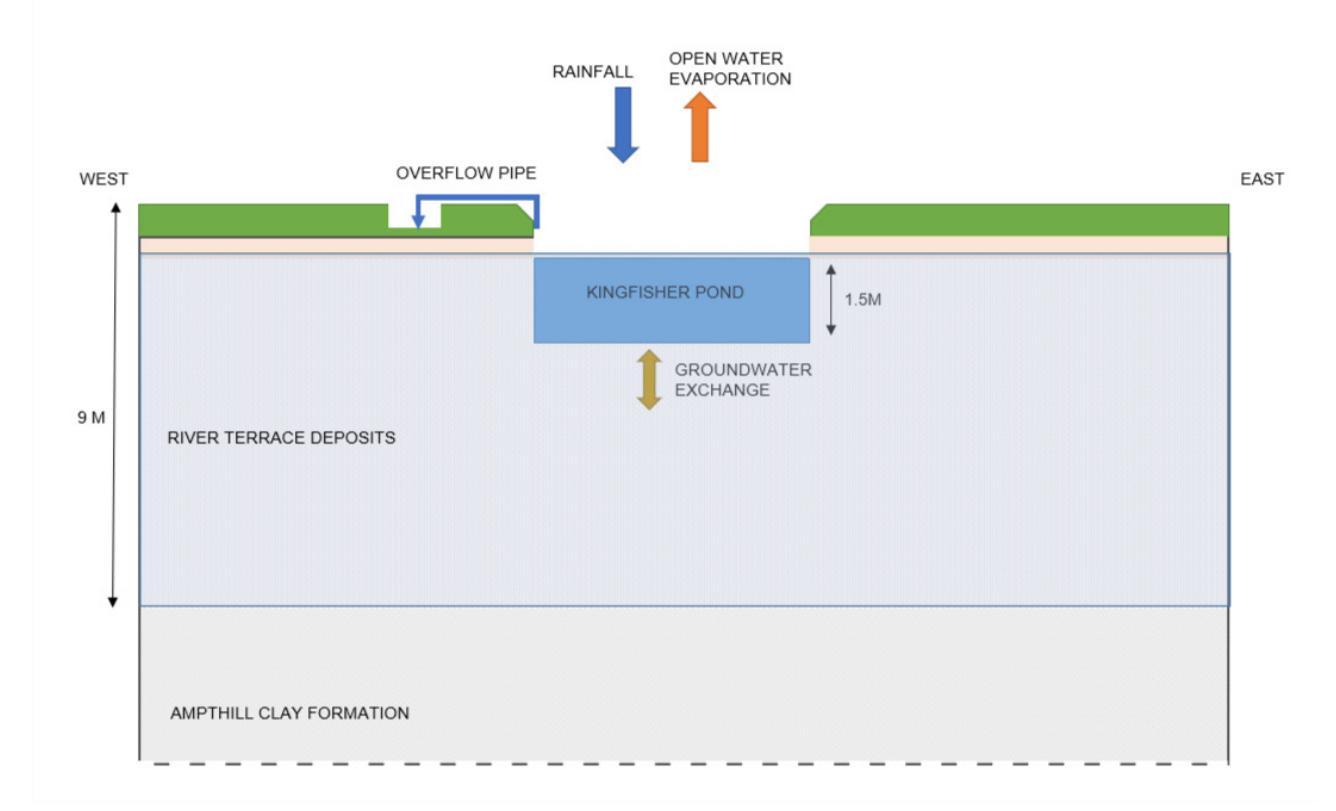
Figure 5.2: Schematic diagram describing the hydrogeological interaction of the Kingfisher Pond with the RTD aquifer

- Rainfall falls directly on the pond and onto the RTD, topping up the pond and increasing groundwater levels.
- There will be evaporation from the pond particularly during summer.
- The pond and RTD are in hydraulic continuity, so there is exchange of water between the pond and the RTD, which means that the water level in the pond will change as groundwater levels in the RTD change.
- The RTD is essentially isolated from other aquifers given its linear nature and the underlying AmC.
- The pipe controls levels in the pond.

Notes: All measurements are approximate.

Data from boreholes adjacent to the Kingfisher Pond and records of levels in the pond indicate that the Kingfisher Pond is in hydraulic continuity with the RTD aquifer. The Kingfisher Pond is recharged by the RTD aquifer during normal conditions, changes in the local groundwater level will therefore be reflected in the surface water level of the pond.

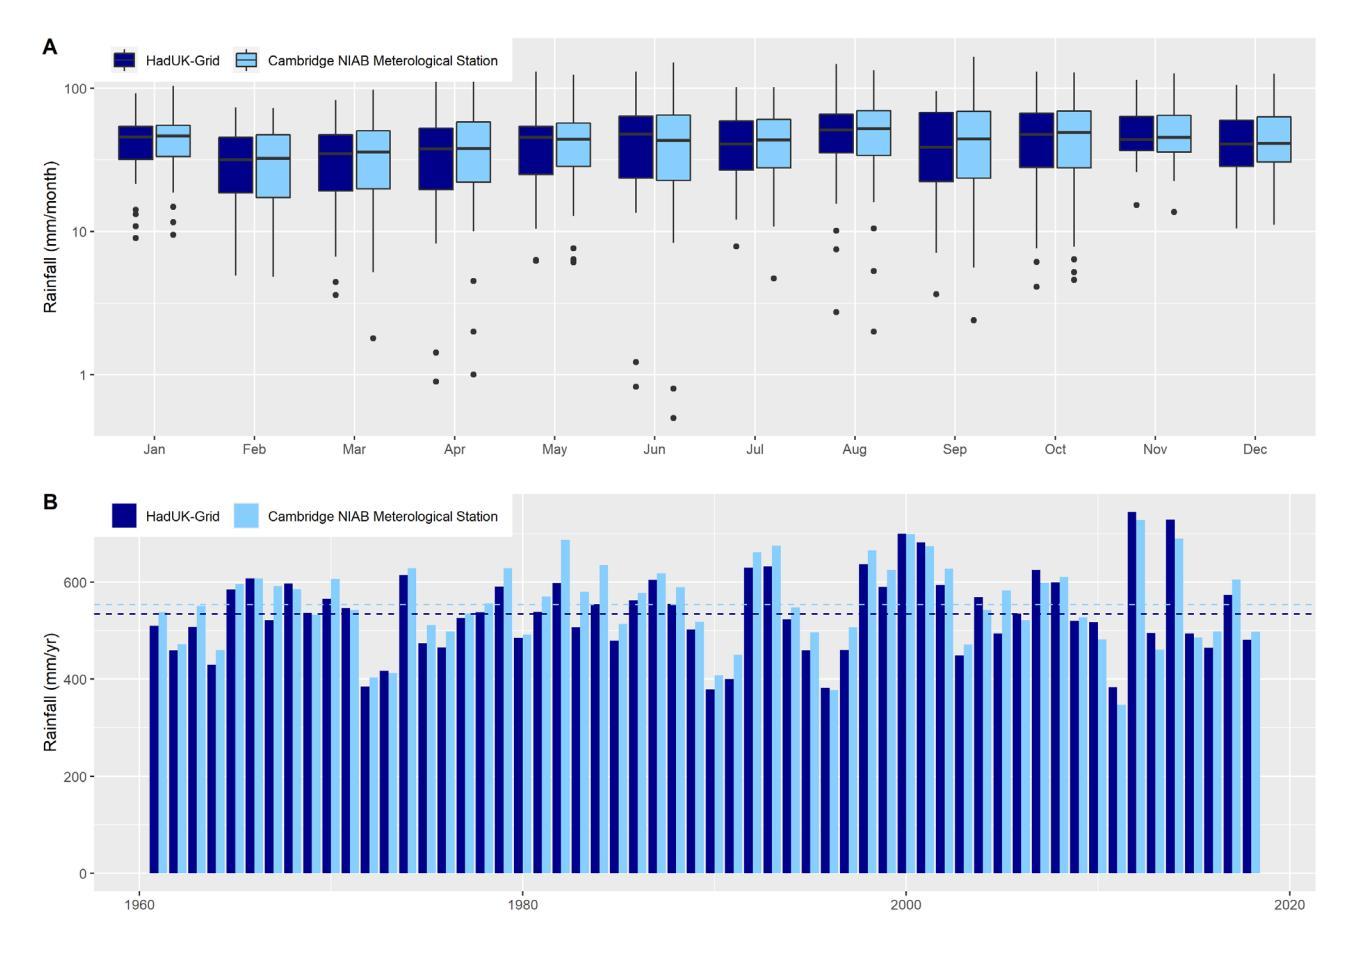
Figure B.1: Comparison of available rainfall data for the local area between January 1961 – December 2014 *Source: HadUK-Gridded rainfall (Met Office, 2019)*

The following graphs in Section B.1. show the comparison of the HadUK-Gridded dataset derived for a 3km buffer around the Kingfisher Pond with the Cambridge NIAB meteorological station. Coincident data is for the period January 1961 to December 2014.

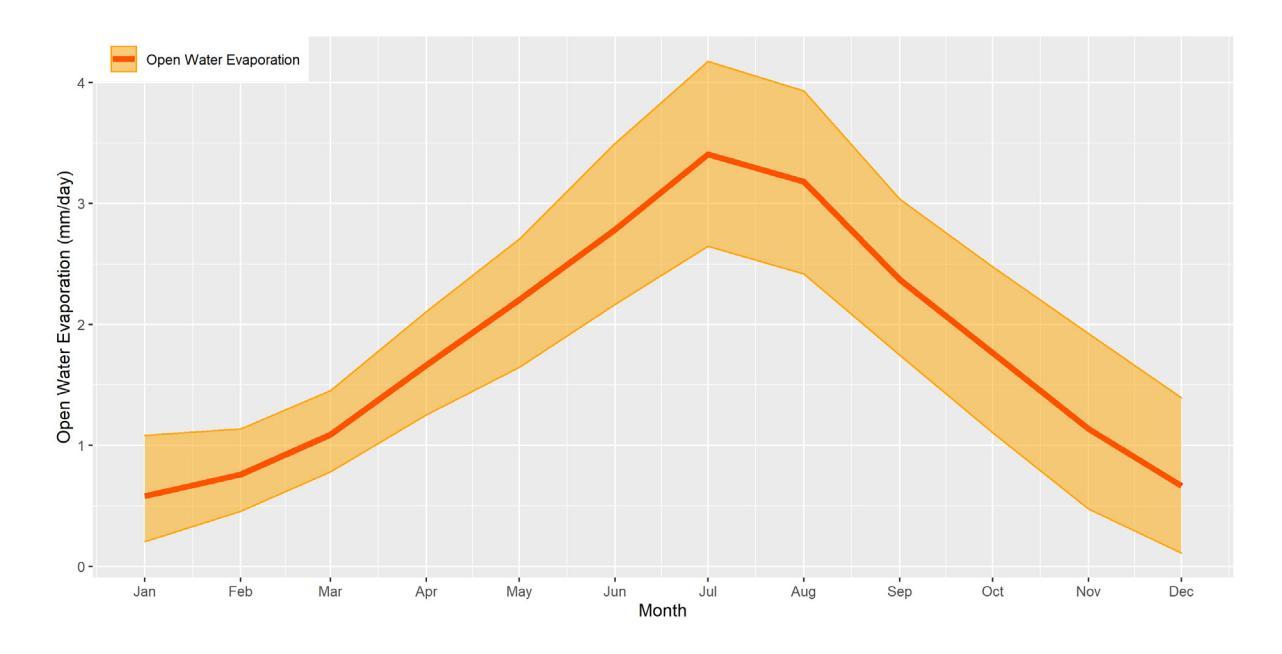
Figure B.3: Monthly profile for the daily average open water evaporation rate derived from potential evapotranspiration at Longstanton . Data from 01/01/1961 to 31/12/2014

Figure B.3 shows the average monthly profile for open water evaporation rate. As expected, peak evaporation occurs in summer when the temperature is highest. Figure B.4 shows the annual average open water evaporation. There is no long term trend indicating that open water evaporation is increasing for the period 1961-2014 The average open water evaporation rate is 1.87 mm/d.

Source: CEH potential evapotranspiration Robinson et al., (2020) converted to open water evaporation using monthly factors developed by the Environment Agency (2001). Dark orange line is the median Q50 monthly evaporation. Light orange ribbon is the range of Q25 to Q75 evaporation range.
