Kingfisher Pond - Northstowe Hydrogeological Assessment

Phase III Report

FWM8714-RT003-R02-00

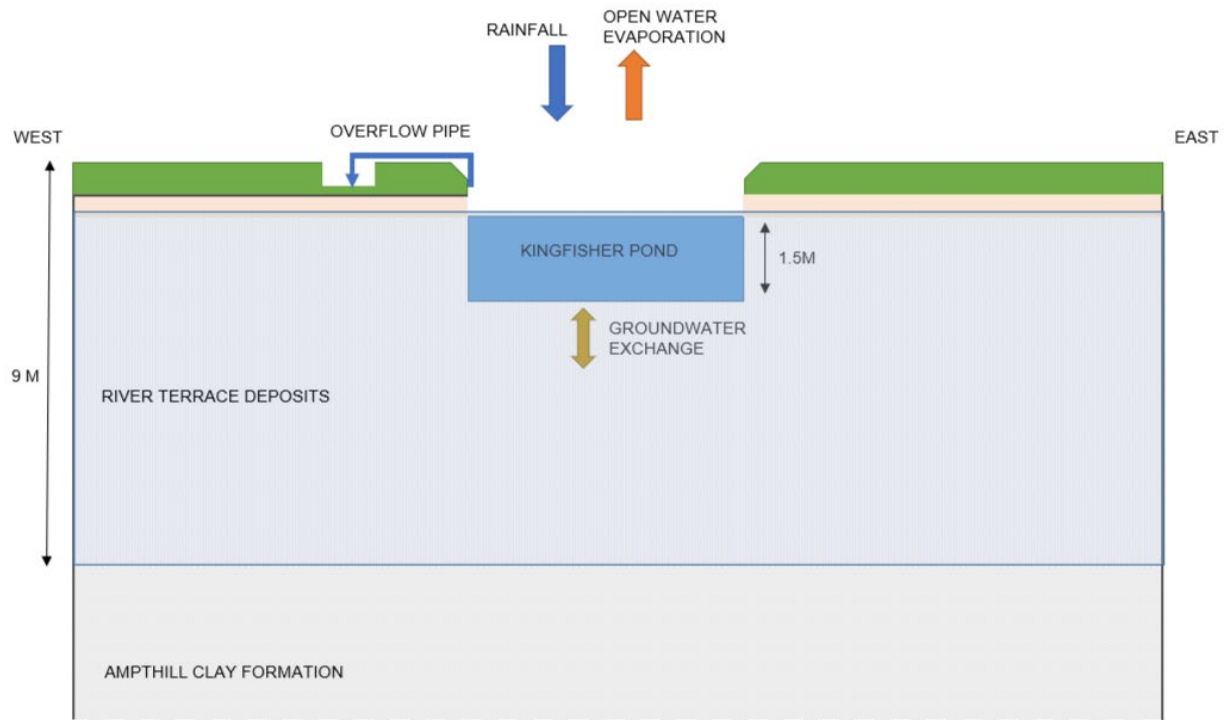
Figure 3.1: Schematic diagram describing the hydrogeological interaction of the Kingfisher Pond with the RTD aquifer

Figure 3.1 presents a conceptual diagram of the pond and the underlying geology. This diagram displays a conceptualisation of the exchange between groundwater and surface water. Figure 3.2 presents the BGS 1:50 000 drift deposit map (BGS, 2020c) highlighting the location of the Kingfisher Pond within the RTD.

Notes: All measurements are approximate.

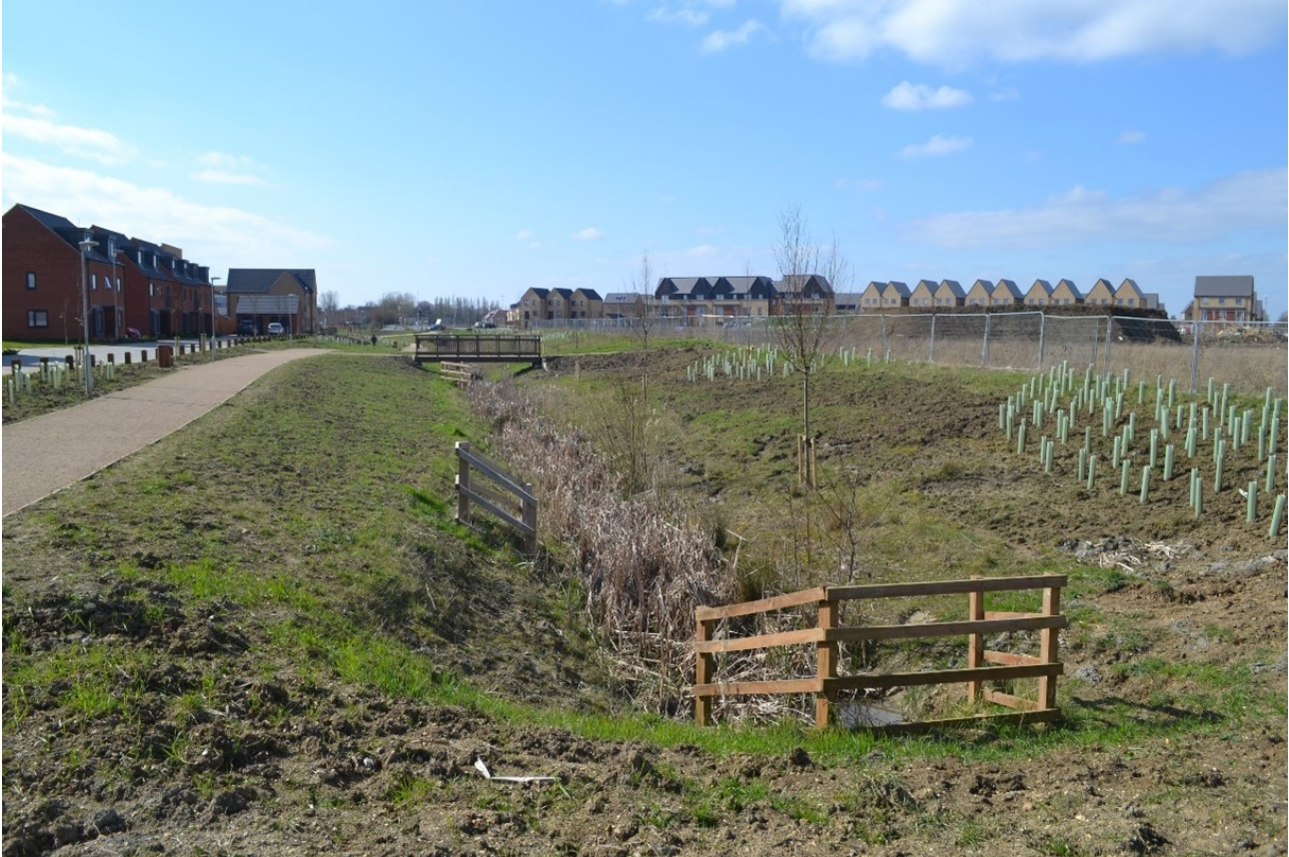
Photograph 4.1: Greenways on the site of Northstowe

The design of Northstowe includes the installation of ditches (referred to as greenways) to prevent flooding. These greenways provide a preferential flow pathway allowing water to travel attenuation ponds. The attenuation ponds are an artificial feature and are not in hydraulic continuity with the RTD. Therefore, water is able to be sustained in the attenuation ponds during periods where the groundwater elevation in the RTD is below average. A key design principle was to maintain the greenways above the water table otherwise the greenways would convey groundwater from the aquifer towards the attenuation ponds (Wardell Armstrong, 2017). Given the shallow groundwater table, careful construction of the greenways would be required to prevent permanent lowering of the water levels in the RTD.

WSP (2014) state that the typical water level in the RTD is 0.5 to 2 m below ground level. Photograph 4.1 (HR Wallingford, 2021) shows a typical section of one of the greenways. In this photo it is apparent that there are long sections of the greenways which are greater than 0.5 m deep. It is unclear if the design principle of maintain the greenways above the water table has been met. There is a possibility that these greenways are located below the natural water table in the RTD in some sections.
